CASE STUDY

BOLSTER TOP & BOTTOM

FOR 1600 TON PRESS

CUSTOMER :VIJAYA LAKSHMI FORGINGS, COIMBATORE.

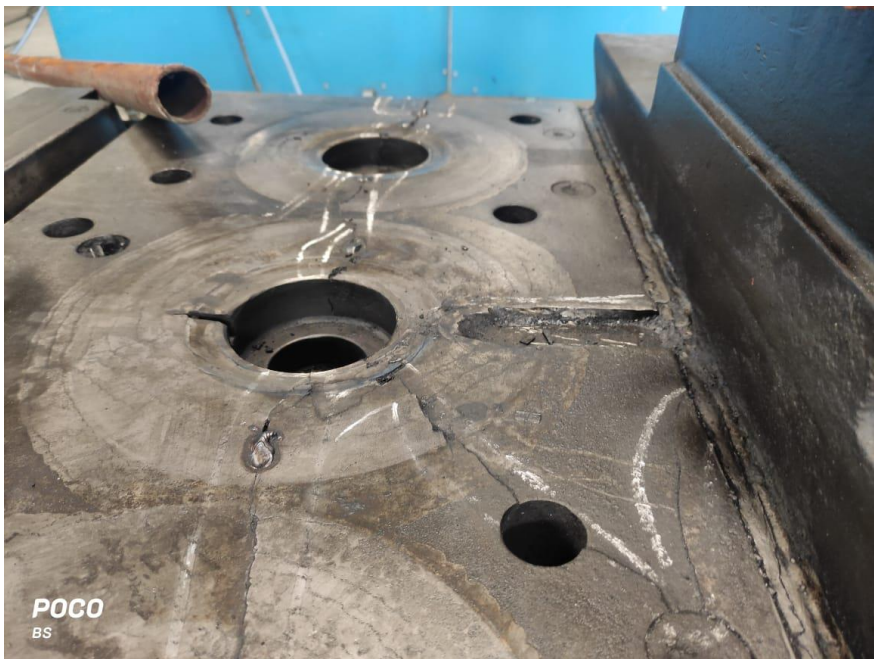
Photo:02 - Cracked Bottom Bolster

During the operation of forging a continuous compression load comes to the Bolster through die. Over a period of time the bolster Fatigue & start developing small cracks. If those fatigue cracks are not handled on time this starts developing throughout & leads to cracking bolster into two parts which has happened in the case in Discussion.

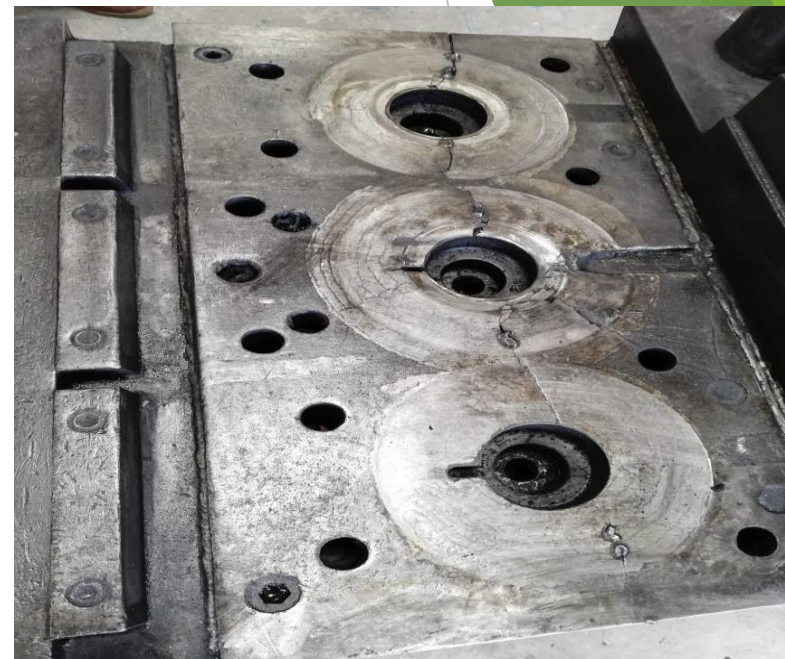
Photo:03 - Bolster for Repair

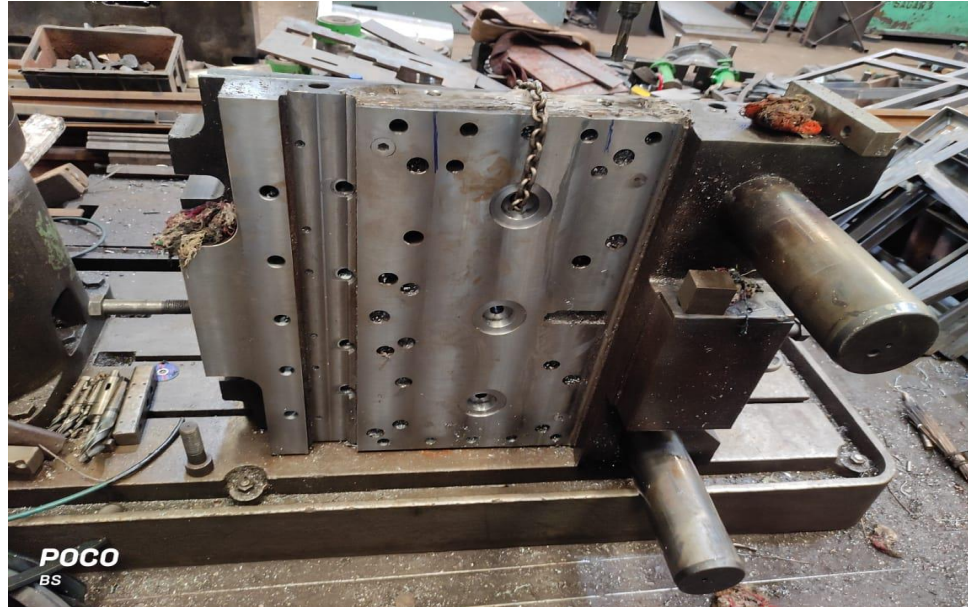
Photo:04- Machined Bolster Bottom

COMPONENT	:BOLSTER TOP & BOTTOM.
MATERIAL	: DIN.1.2714.
COMPOSITION	: C 0.5, Si0.25, Mn 0.7, Ni 1.7, Mo 0.5, V 0.1.
WEIGHT OF BOLSTER	: 1.6 Tons.
PRODUCTS USED	: GOUGING , EXCL BOND 086, EXCEL FORGE 011.

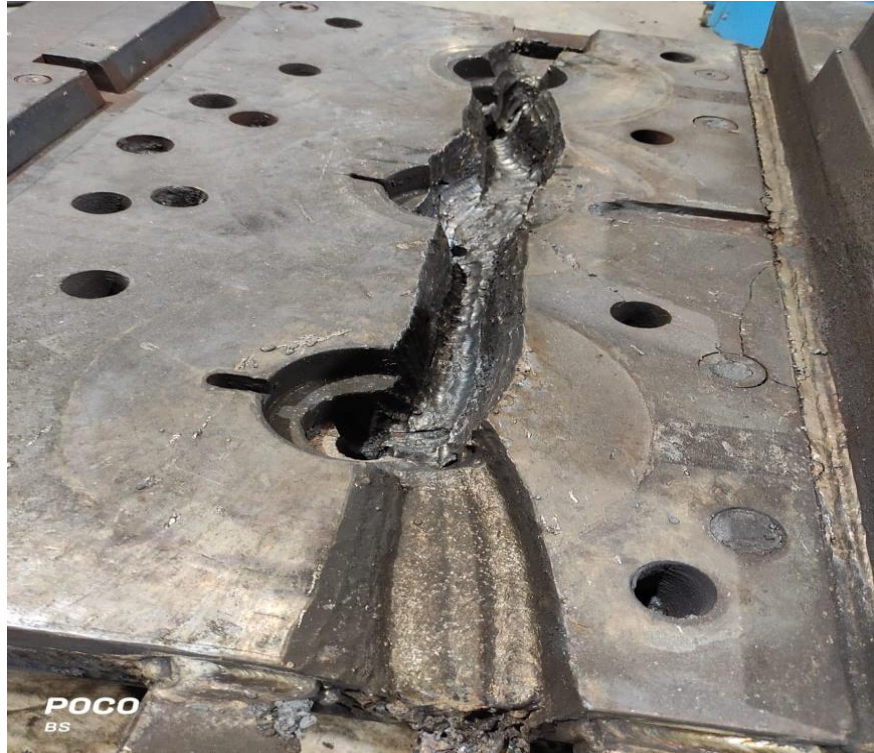
Photo:05 - Removed the crack by Gouging process & Grinding

- Gouging is the method used to remove the material w/o much heat input.
- All cracks were marked and strategy was made to open cracks by gouging from both sides.
- Gouging of the cracks 60% from working side & 40% from non working side.

Grinding is done on gouged area to remove the metal spatter & molten material.

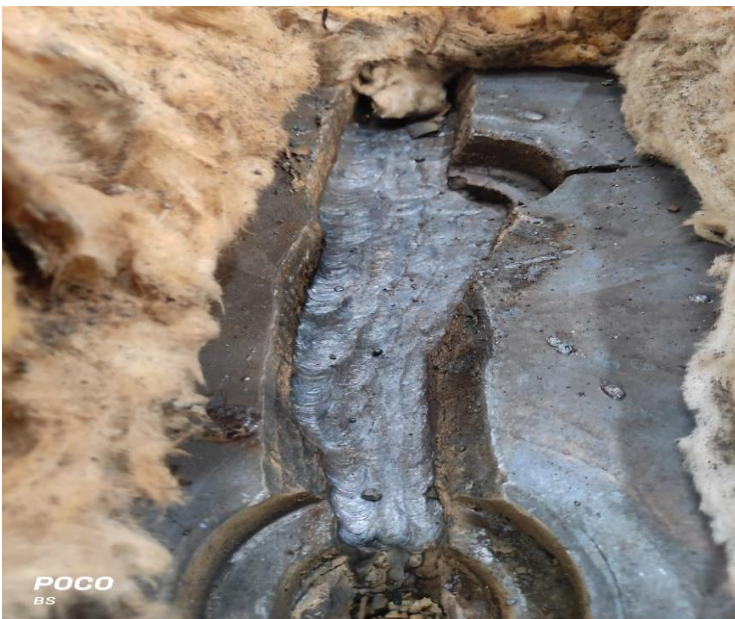
Photo: 06 - Welding on Gouged area

- ▶ Before starting the welding process, The Whole Bolster Bottom is Pre-heated using a Long Burner & gas for 320 deg. Celsius for 12 hours.
- ▶ Carbon Equivalent was checked & preheated.
- ▶ Welding process:
- ▶ Excel Forge 011 & Excel Bond 086.
- ▶ Stress Releasing will be done @ temperature 560° C after completion of Welding Process

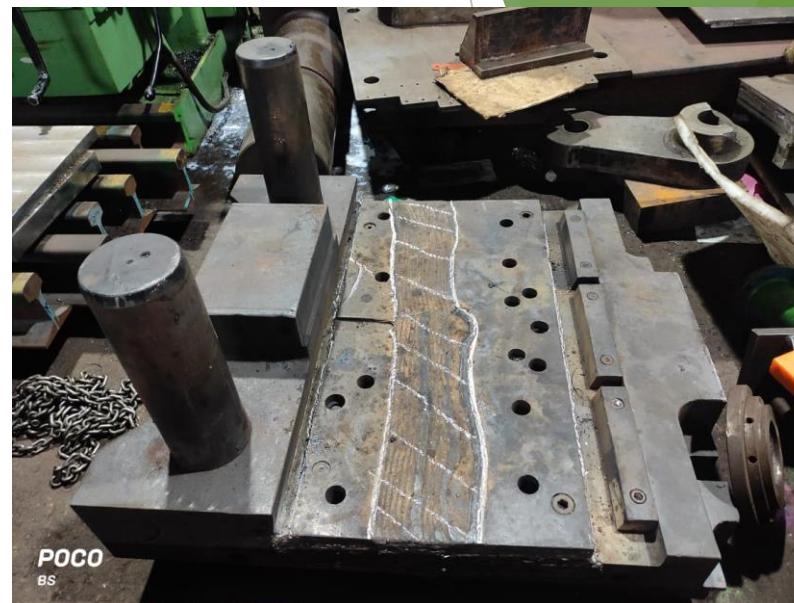
Photo: 07 Completion of Welding

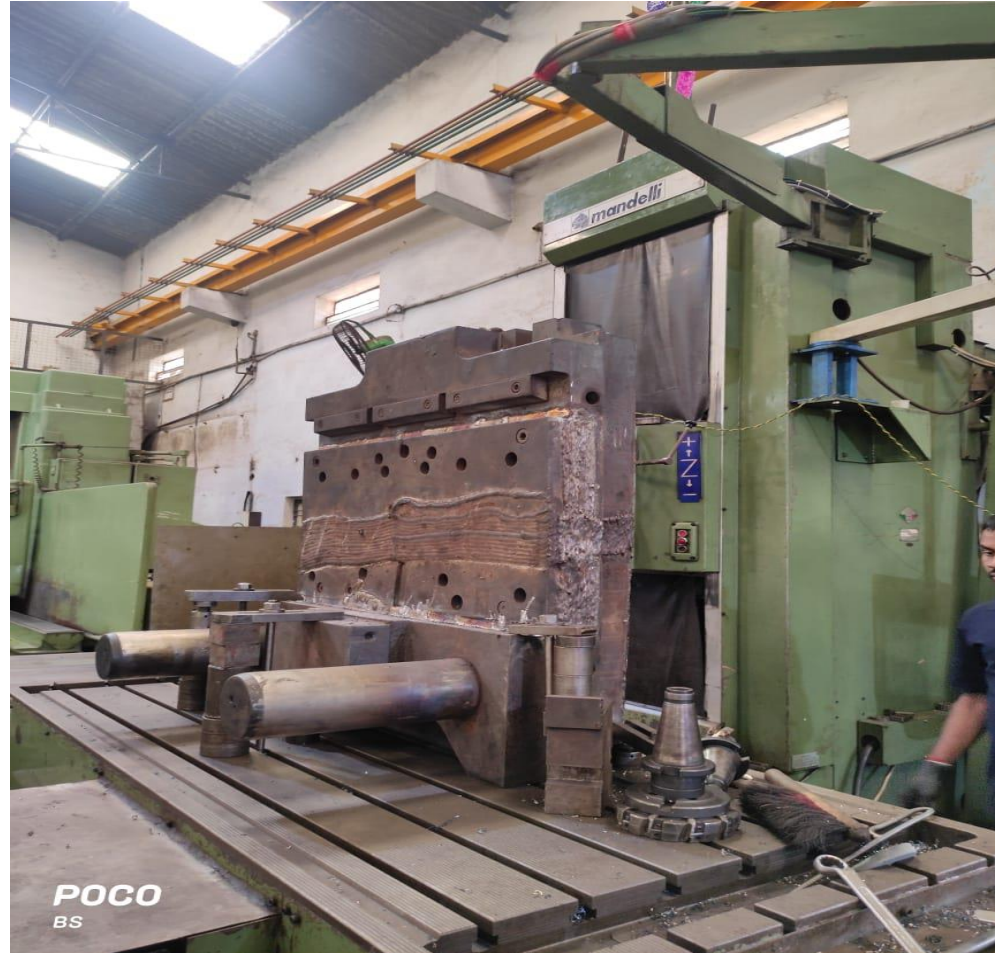
Photo : 08 Bolster mounted
in VMC Machine

- ▶ After Completion of a welding process, the Bolster is machined to maintain parallelism of the 2 sides.
