# Excel Craft Private Limited

## WELDING DIVISION

### CASE STUDY OF CLUTCH PLATE HOUSING

<b>CUSTOMER</b>	: BANSAL PRECISION FORGE
<b>COMPONENT</b>	: Clutch Piston End Plate.
<b>MATERIAL</b>	: Cast Iron
<b>EQUIPMENT</b>	: 2500 TON PRESS
<b>JOB DONE BY</b>	: Mr.Samir Rahate

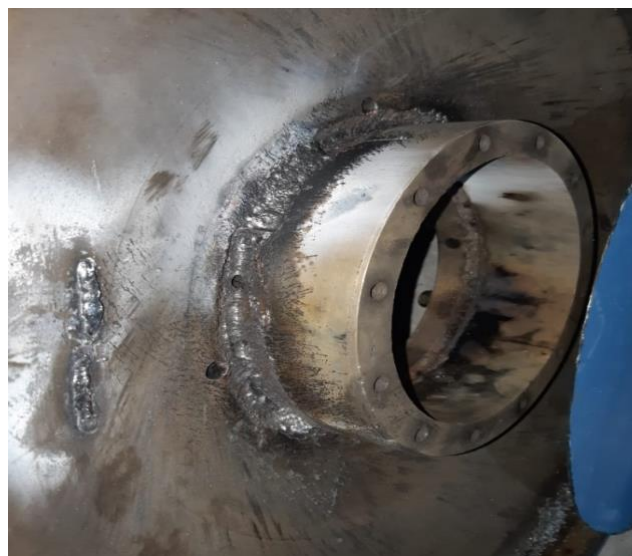
PHOTO- B

**PROBLEM STATEMENT** – The collar of the Clutch Plate got cracked, due to continues Torque load as the press was in operation for 25yrs. “It was a fatigue failure due to which press was not operational. As shown in Photo B.

1. **Gouging:** of the cracked area and open the same in order to remove the fatigue and uneven material.
2. **Preheating:** Up to 180<sup>o</sup> C the component is heated using furnace for the purpose of oil removal. As the Cast iron was oil soaked, preheating of the job was done for 30 min to remove the oil.

3. **Welding:** Welding was carried out on the cracked area. After welding DP test was done on the job and found to be perfectly OK.

4. **MACHINING:** After the job was done, it was sent for machining as per drawing and the press became operational within 18 hrs.
