Excel Craft Private Limited

CASE STUDY OF ENGINE CASTING REPAIR

CUSTOMER	: ACCU PRECISION
COMPONENT	: Bottom Casing of Turbine.
MATERIAL	: CI-FG 300.
WEIGHT	: 2286 Kgs
PERSON INVOLVED	: Mr. Samir Rahate & Syed Zabiulla

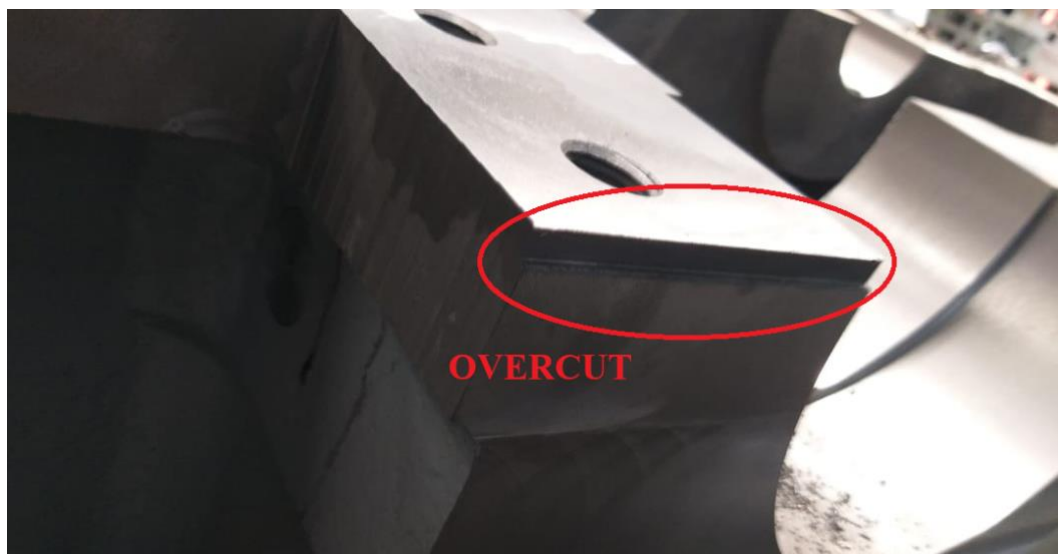
PHOTO- B

PROBLEM STATEMENT – Casting defect with pin holes, overcut while machining. As shown in Photo B

1. **Welding:** Welding was carried out on the overcut keeping a machining allowance of 1-2 mm. After completion of the welding, GRINDING was done for surface match and colour match. Then DP test was carried out to find out any cracks or defect in the weld.

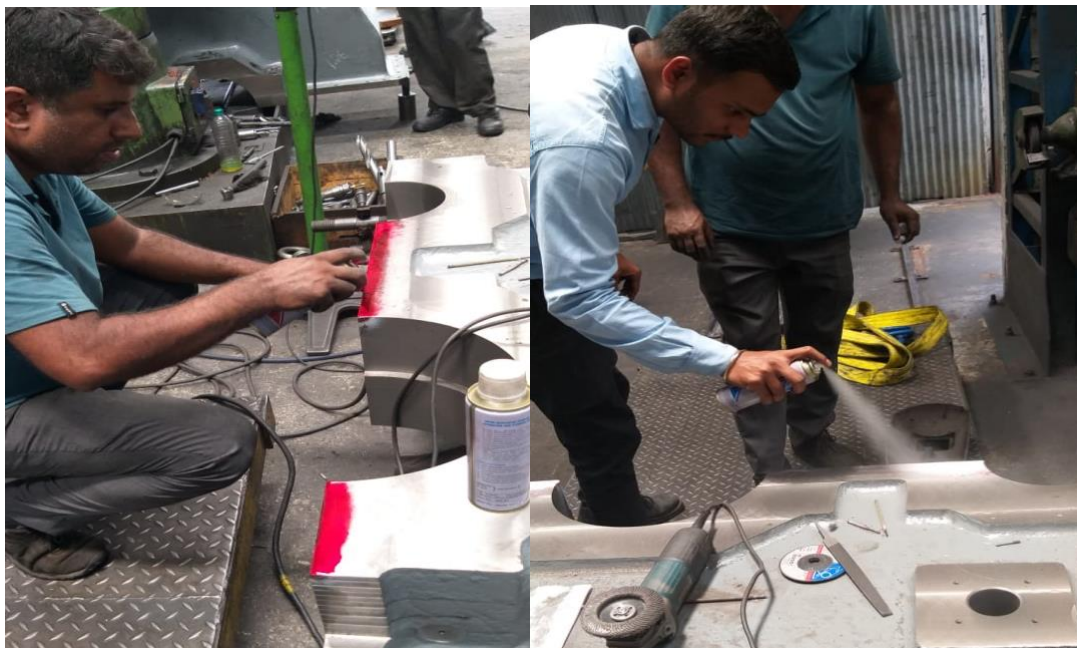
2. **DYE PENETRATION TEST:** is applied and low-cost inspection method used to check surface-breaking defects.
