# Excel Craft Private Limited

## WELDING DIVISION

### CASE STUDY OF PINION

**CUSTOMER** : BANSAL PRECISION FORGE  
**COMPONENT** : PINION.  
**MATERIAL** : CAST STEEL  
**EQUIPMENT** : 2500 Ton PRESS  
**JOB DONE BY** : Mr. Samir Rahate  
**Date** : 26/09/2019

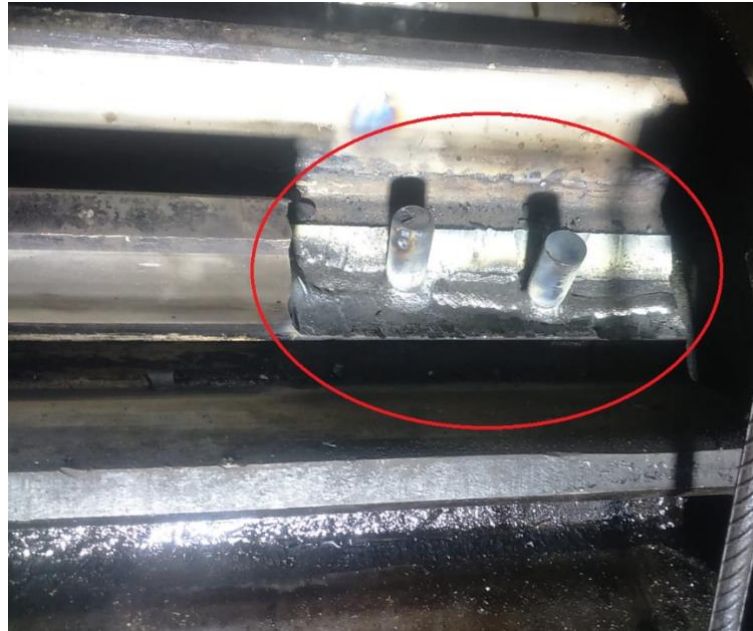
PHOTO- B

**PROBLEM STATEMENT** – The Tooth of pinion gear was broken which was weighing 8kgs. As shown in Photo B

1. **Job Preparation:** Oil was cleaned up. Grinding was done on the broken area. Drilled 20mm deep hole and studs were inserted into the hole to strengthen the gear teeth welding as shown in photo A.
2. **Preheating:** Up to 250<sup>o</sup> C the component is heated using gas torch as per the carbon equivalent.
3. **Welding:** First two layers was build up with EXCEL BOND 066 and remaining profile was welded with EXCEL BOND 0086. After completion of the welding reheating (Stress reliving) of the job was done to reduce the stresses.
