# Excel Craft Private Limited

## WELDING DIVISION

### CASE STUDY OF FLYWHEEL

**CUSTOMER** : PHEONIX FORGE PVT LTD  
**COMPONENT** : Flywheel 1.5 Ton Hammer.  
**COMPOSITION** : C 3.523, Si 1.490, Ma 0.724, S 0.0171, P 0.300, Cr 0.024, Ni 0.017, Mo 0.009, Cu 0.016, Mg 0.006.  
**WEIGHT OF FLYWHEEL** : 1.0 Ton  
**PERSON INVOLVED** : Mr. Sameer Rahate & Syed Zabiulla  
**Date** : 26/03/2019 to 28/03/2019

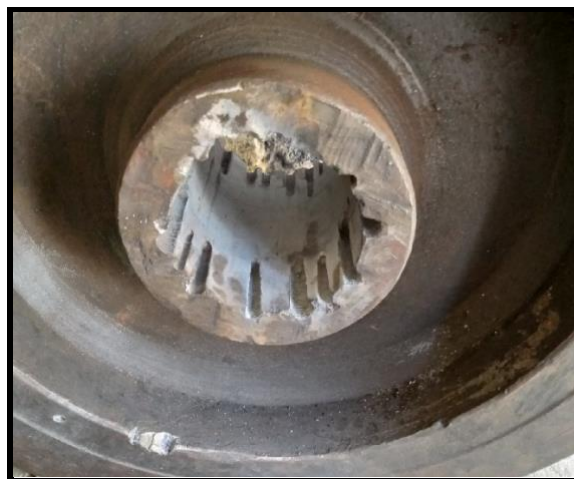
PHOTO- B

**PROBLEM STATEMENT** – The bore of the flywheel got oversized in use and material damaged during taking out the shaft from the flywheel. As shown in Photo B

1. **Gouging:** of the cracked area and open the same by another 4.0 mm in order to remove the fatigue and uneven material.

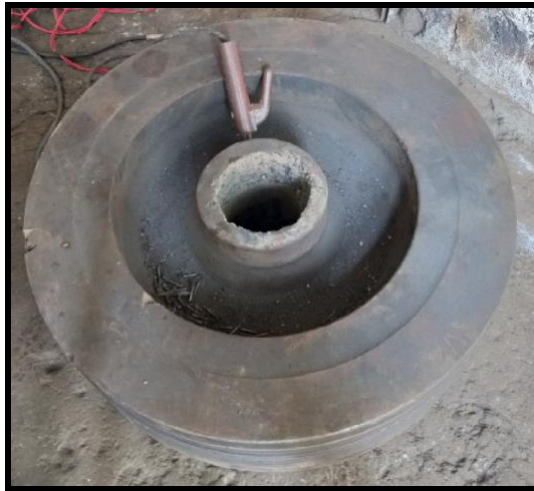
PHOTO- C (Gouging in progress)

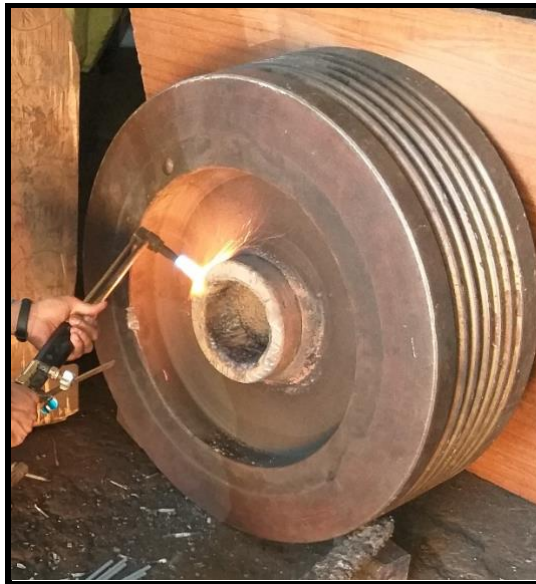
PHOTO- D (Preheating in progress)

2. **Preheating:** Up to 300°C the component is heated using gas as per the carbon equivalent

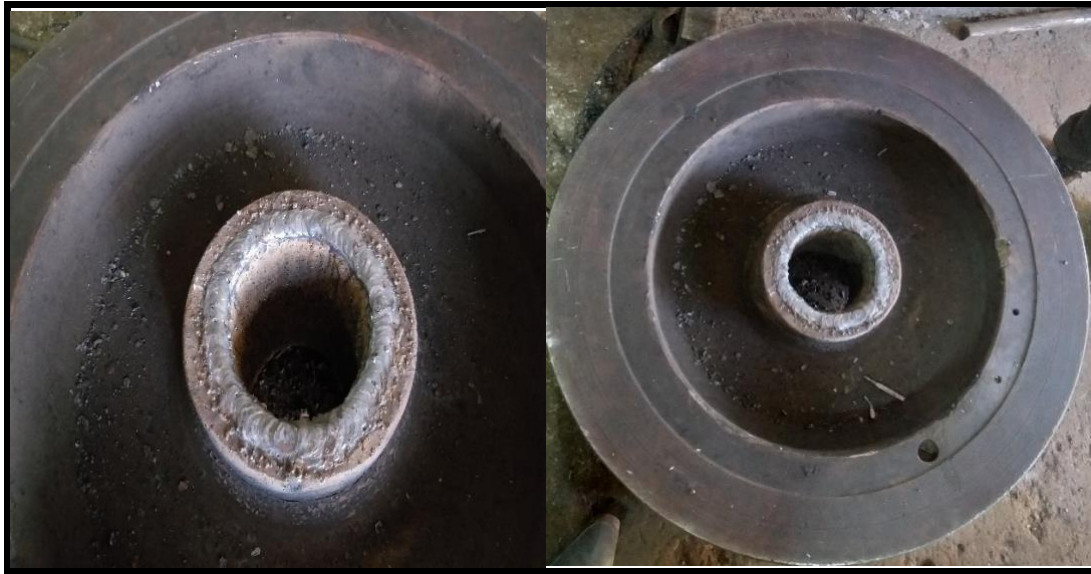
PHOTO- E (Job completed)

3. **Welding:** Welding was carried out from both the sides of the bore keeping a machining allowance of 4-5 mm. After completion of the welding reheating of the job was done to reduce the stresses.

4. **POST WELD TREATMENT:** Upon completion of welding, job was heated up to 400°C locally for post weld treatment and then slow cooled.
5. **MACHINING:** After the jobs attained room temperature, it was sent for machining as per drawing.
